**Mar-Len Gardens Co-Op**  
**SIRS Components**  
***North Miami Beach, FL***

Report #: 51775-0  
Beginning: January 1, 2025  
Expires: December 31, 2025

**RESERVE STUDY**  
**"Full"**

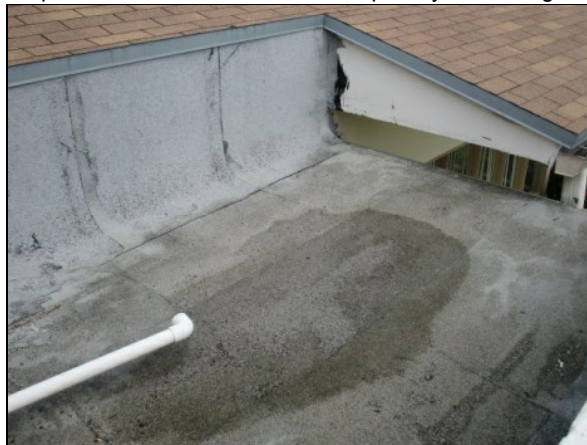
Useful Life:  
20 years

Remaining Life:  
3 years

Best Case: \$ 183,000

Worst Case: \$ 223,000

| # Component | Useful Life<br>(yrs) | Rem.<br>Useful Life<br>(yrs) | Current<br>Average<br>Cost |
|---|---|---|---|
| 2377 Modified Bitumen Roofing - Replace | 20 | 3 | \$203,000 |

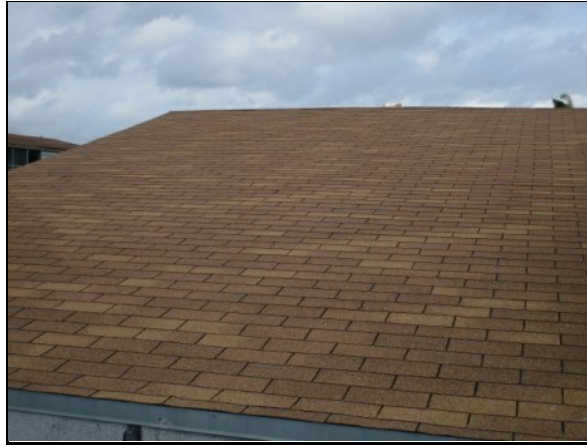
Useful Life:  
20 years

Remaining Life:  
3 years

Best Case: \$ 1,209,000

Worst Case: \$ 1,477,400

| # Component | Useful Life<br>(yrs) | Rem.<br>Useful Life<br>(yrs) | Current<br>Average<br>Cost |
|---|---|---|---|
| 2381 Asphalt Shingle Roofing - Replace | 20 | 3 | \$1,343,200 |
